**DELAWARE RIVER BASIN
ROCK RUN CREEK, CHESTER COUNTY**

**PENNSYLVANIA
ID NO. PA.00059**

ROCK RUN DAM

PHASE I INSPECTION REPORT NATIONAL DAM INSPECTION PROGRAM

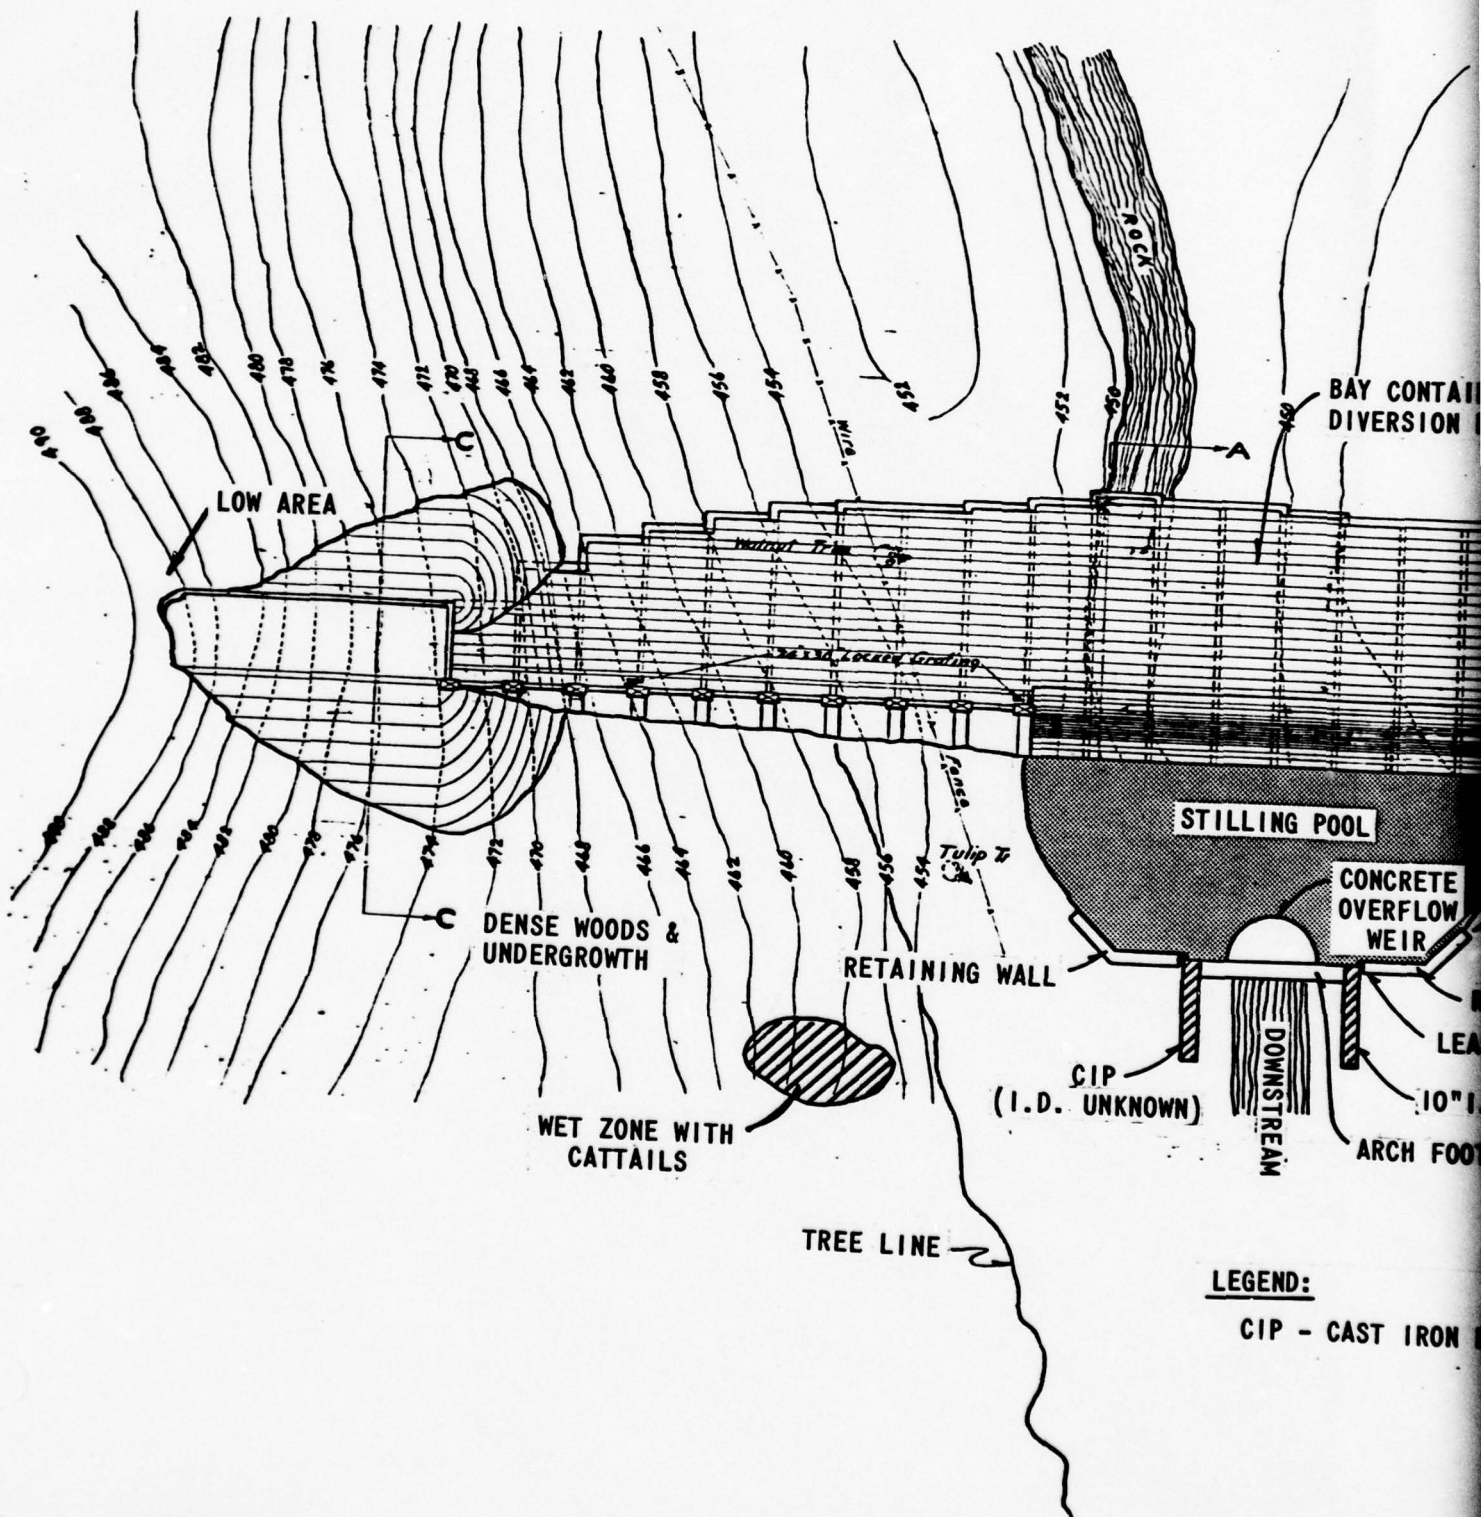
NOTES: 1) MANY UPSTREAM CONSTRUCTION JOINTS LEAK. SOME HAVE HAIRLINE CRACKS.

2) MANY OF THE PLASTER FILLER PLATES (NOT STRUCTURAL COMPONENTS) ARE DETERIORATED, AND HAVE MOVED

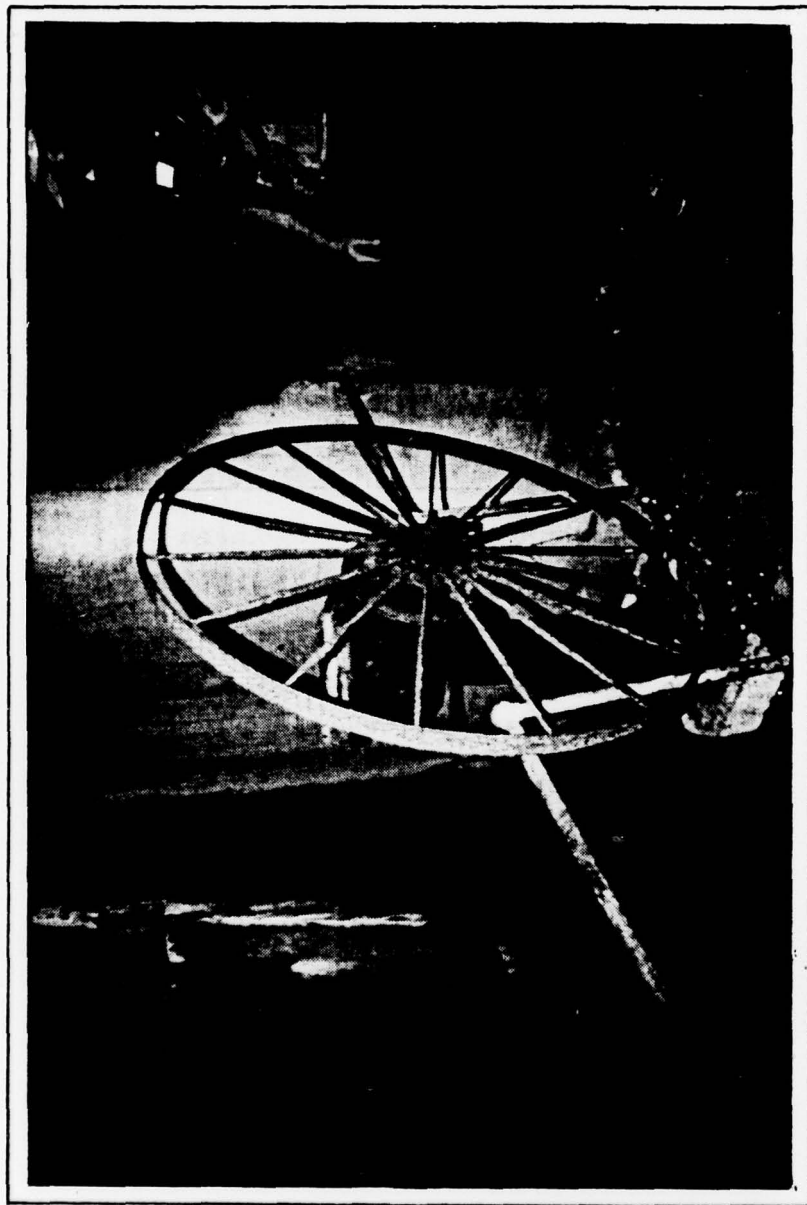
PHOTOGRAPH NO. 2

The lower 24-inch pond drain pipe could not be inspected since it was covered with soil. Exposed portions of the gate valve were observed and it was leaking at the stem. An attempt was made to exercise this valve, but the leakage became excessive and further exercising of the system was terminated.

ABANDONED POND DRAIN VALVE THAT
LEAKS AND IS LOCKED (FROM RUST)
IN THE CLOSED POSITION. INTAKE
PIPE IS REPORTEDLY FILLED WITH
SEDIMENT.

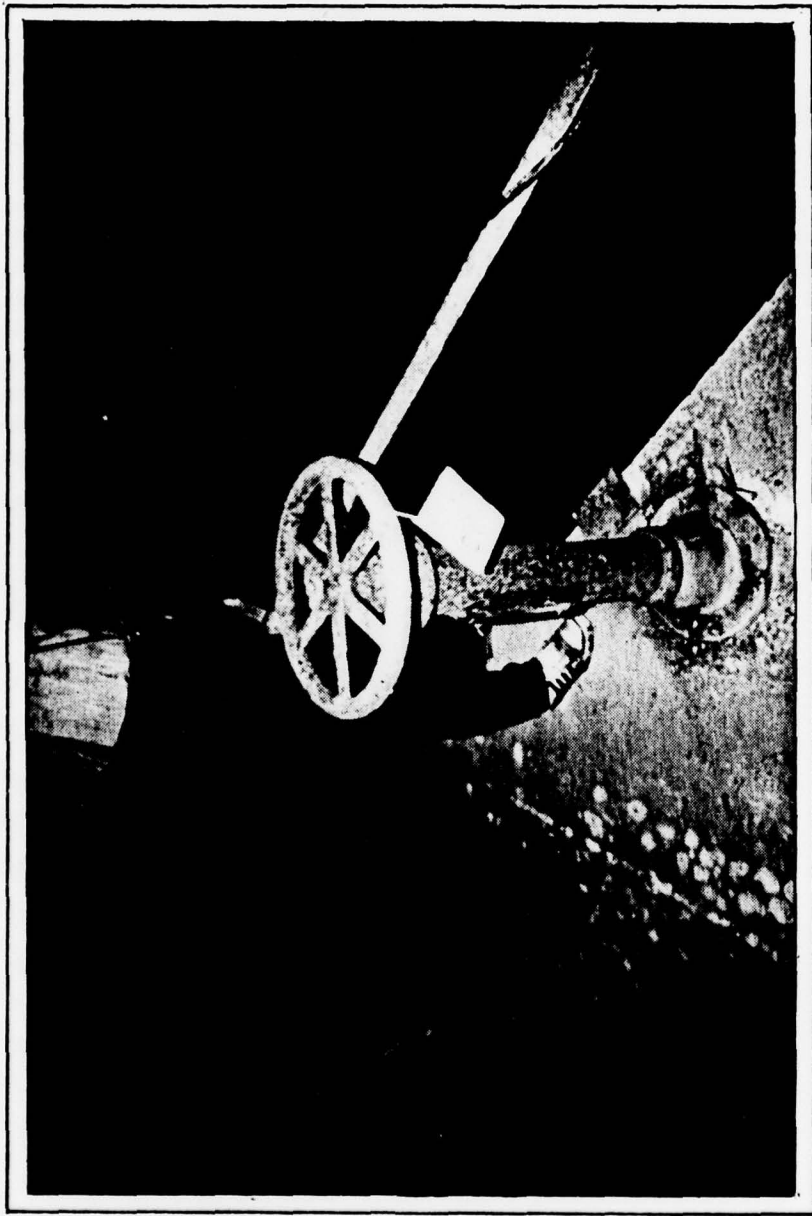
1. Intake Pipes. The intake pipes are assessed to be in good condition, but the valves in the pipes are assessed to be in poor condition. It is noted that only the upper intake pipe is functioning, and it is reported by the plant operator that that valve is essentially locked in the open position. It is reported by the Owner's representative that the middle intake pipe, although observed to be in good condition, is silted-in and the valve is rusted shut.

ABANDONED VALVE FOR MIDDLE INTAKE PIPE.

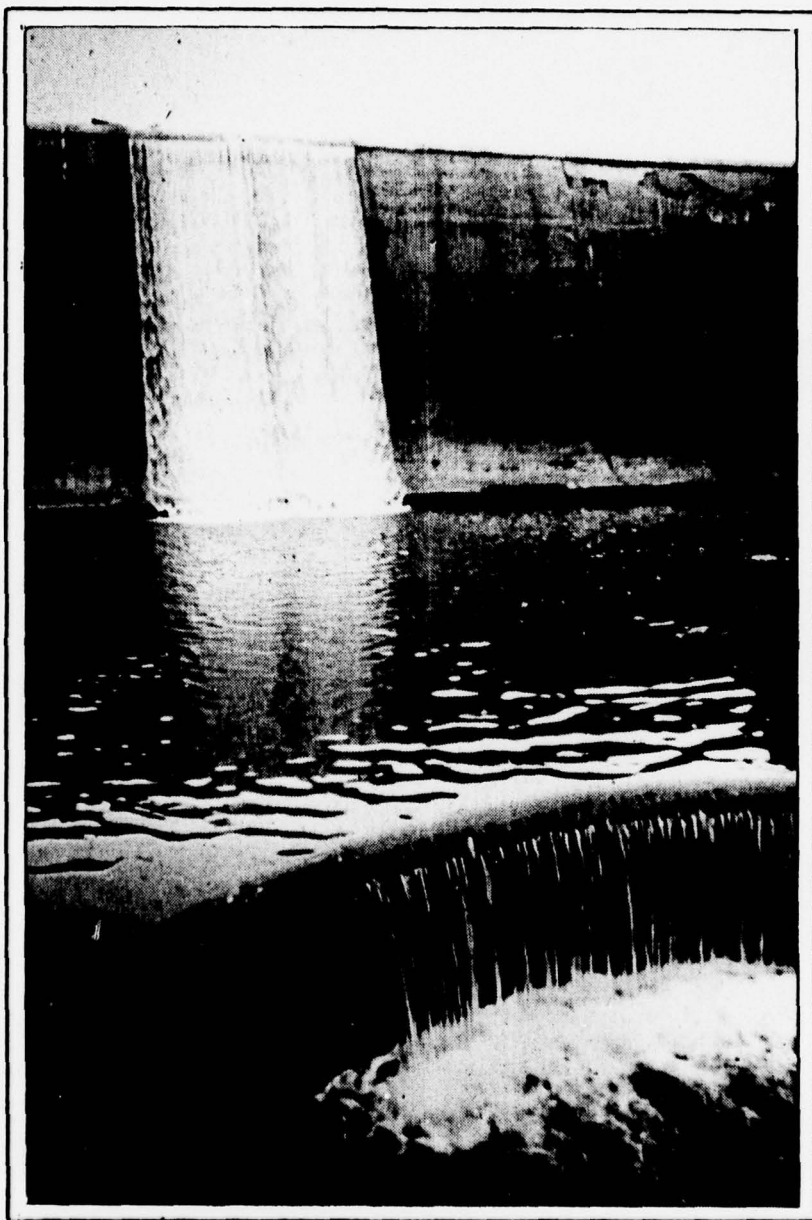
PHOTOGRAPH NO. 7

DOWNSTREAM STILLING BASIN
AND OVERFLOW WEIR.

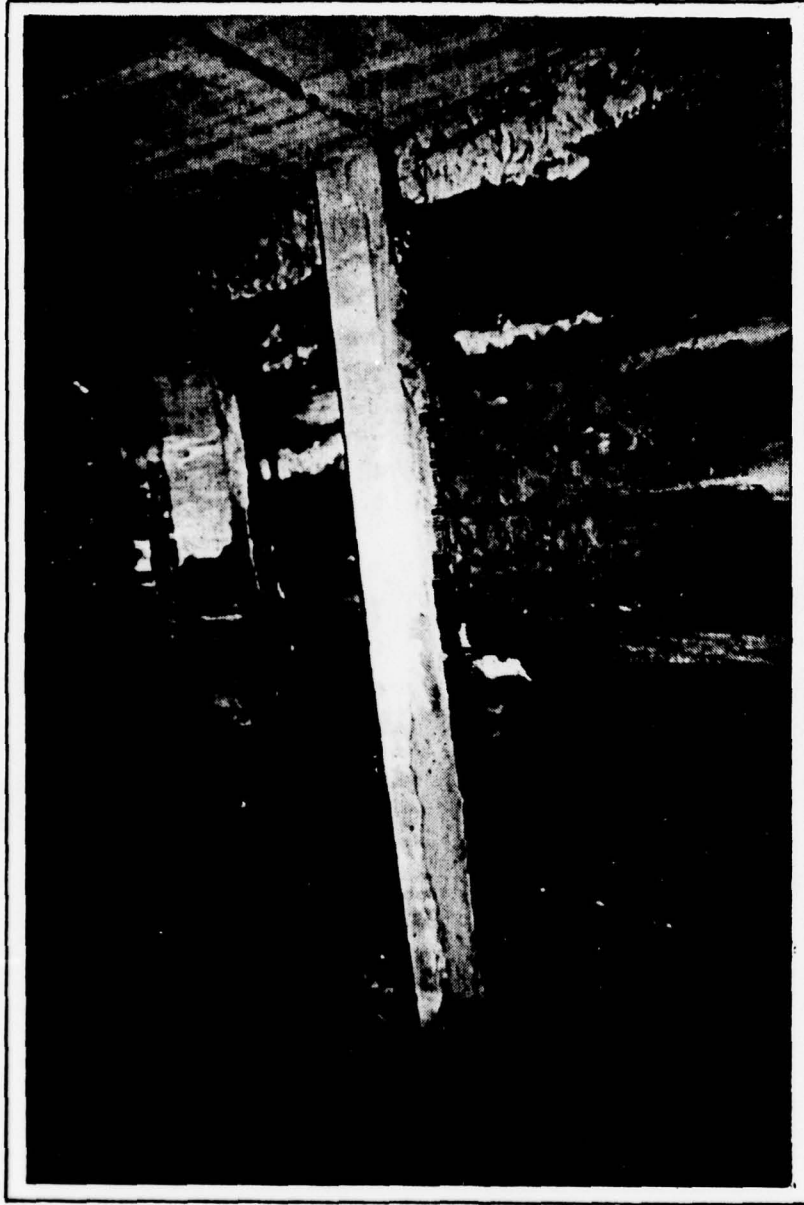
PHOTOGRAPH NO. 8

The plaster filler walls on the downstream face between buttresses were often cracked, buckled, and generally in poor condition. It is noted, however, that these are not structural components, but only facial components. Although the reason for installation of the plaster filler walls was not found in these files, analysis of other similar dams indicates that the downstream facing was installed for two purposes. The first and primary purpose was to minimize temperature changes on the underside of the upstream slab, thus minimizing spalling and deterioration of the slab. As a secondary purpose, the downstream facial wall was placed for aesthetic reasons.

VIEW FROM INSIDE OF DAM LOOKING
DOWNSTREAM TOWARDS FACIAL WALLS
AND BUTTRESS TIE BEAM. NOTE WALL
DETERIORATION AND MOVEMENT. MANY
OF THE TIE BEAMS ARE ALSO DETERIOR-
ATED.

1. A registered professional engineer should evaluate the downstream struts between buttresses. As necessary, these struts should be rehabilitated or recoated with suitable materials to prevent further deterioration of the reinforcing steel.
2. Rehabilitation should also include the downstream plaster filler walls and repair of the spalled concrete along the spillway and the parapet wall.

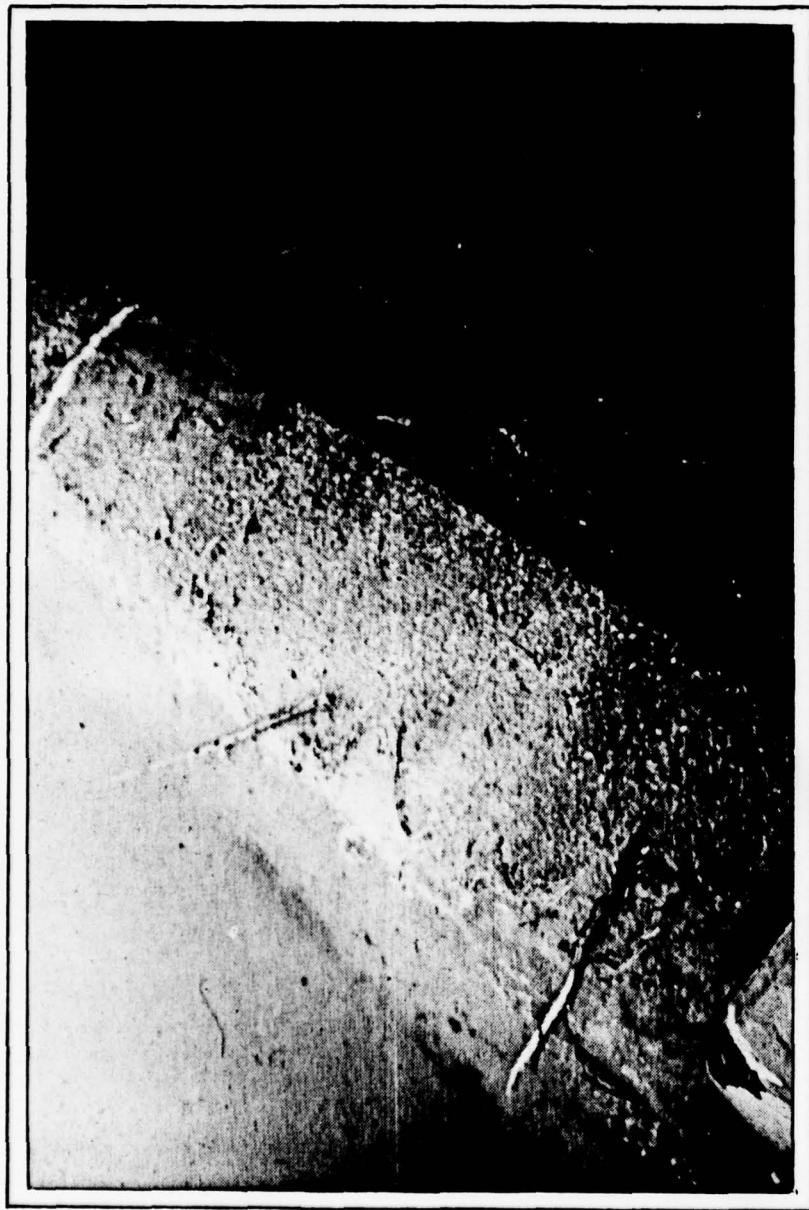
2. Spillway. The spillway was inspected and observed that the crest was in good condition. However, the spillway chute below the cap was observed to be spalled and some displacement was noted between the downstream chute and the weir cap. The stilling basin immediately below the spillway is rock lined and relatively stable. Water flows over a notched 25-foot diameter semi-circular weir, and then discharges into the downstream channel.

CLOSEUP VIEW OF SPILLWAY CREST.
NOTE SEPARATION (1 to 2 INCHES)
BETWEEN CAP AND CHUTE.
